## Exhibit C

**Intentional Oxidation of Prolene Mesh**

**Supplemental Report of Dr. Shelby F. Thames**

**August 8, 2016**

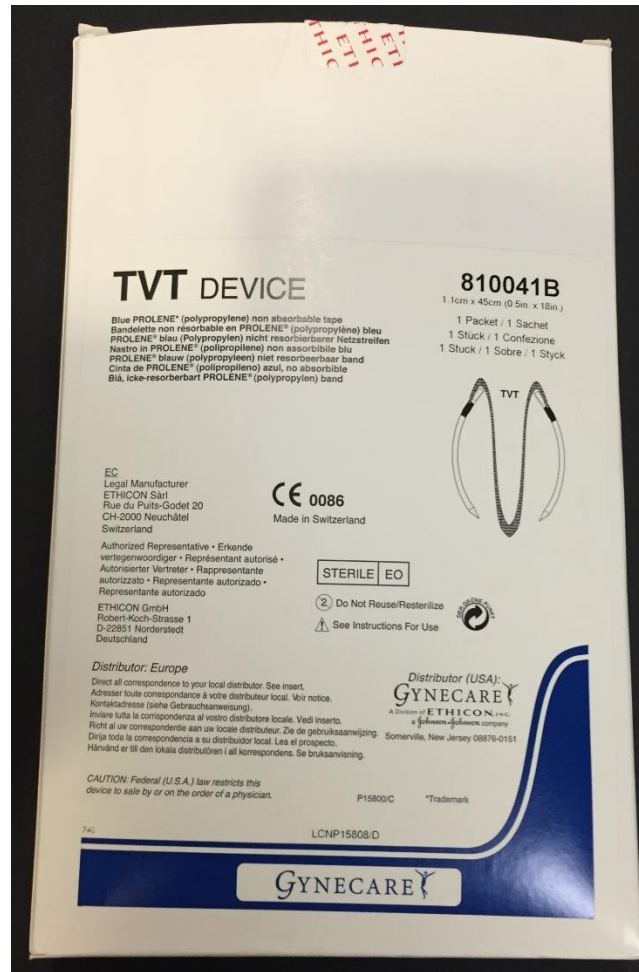
Figure 2. Exemplar Gynecare TVT Device 810041B

A sample size of approximately 10 mm x 10 mm of the exemplar TVT device, lot 810041B, as noted in Figures 2 and 3, was placed in the UV exposure chamber (Figure 4).

**April 12, 2016** – An approximately 10 mm x 10 mm exemplar Prolene mesh (Gynecare TVT device 810041B, Lot #3694576) was cut from an exemplar TVT device previously received on September 20, 2013 from Exponent Laboratories. This exemplar sample was maintained in our laboratories since receipt.

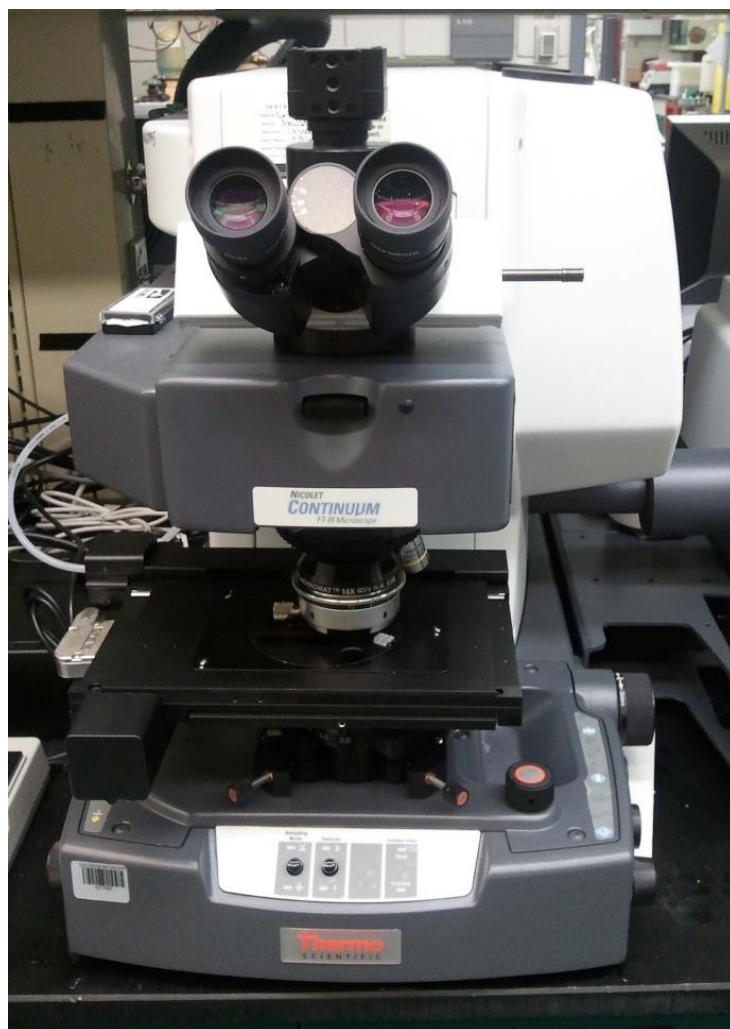
**Figure 5. Thermo-Nicolet Continuum FTIR Microscope**

The pristine exemplar TVT sample was characterized via Fourier Transform Infrared Microscopy (FTIR) with a Thermo-Nicolet Continuum FTIR Microscope (Figure 5) prior to UV exposure. The resulting spectrum (Figure 6) contains an inset image showing the penetrating IR beam location. The absorption frequency at  $1742\text{ cm}^{-1}$ , indicative of Ethicon's DLTDP antioxidant, is also noted in my previous reports, which I rely upon, and is present in the spectrum.
